Manhole Inspection Summary

Manhole # S19W__027MH

Insp Date: **7/1/08 8:48 AM**

Location Address: **2308 monterey st**

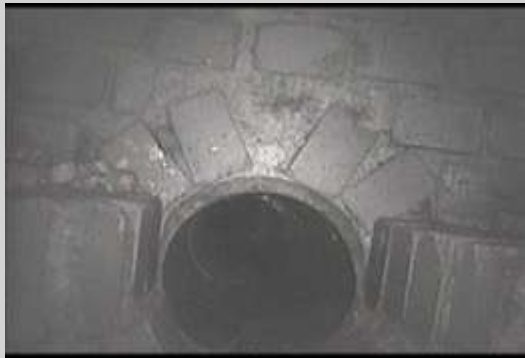
12 O'Clock Outflow

8 in. Circular Gravity Sewer
Pipe Out @ 12 O'Clock

Pipe Height: **8.4** (in.) Rod and Bar (Angled)

Pipe Material: **Clay** ☐ Pipe Lined

Invert Depth: **11.94** (ft.) Flow Characteristics: **Slow**

Infiltration: **None** Pipe Seal Cond: **Sound**

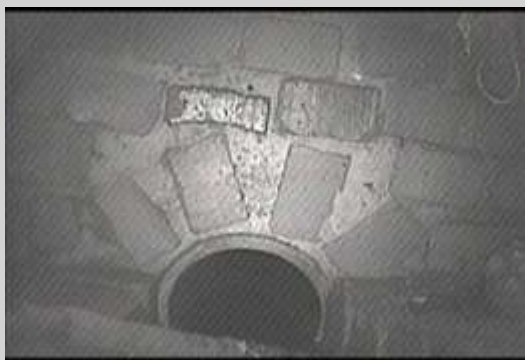
3 O'Clock Inflow

6 in. Circular Gravity Sewer
Pipe In @ 3 O'Clock

Pipe Height: **6** (in.) Rod and Bar (Angled)

Pipe Material: **Clay** ☐ Pipe Lined

Invert Depth: **11.62** (ft.) Flow Characteristics: **Slow**

Infiltration: **None** Pipe Seal Cond: **Sound**

Connects To: **House connection / Service line**

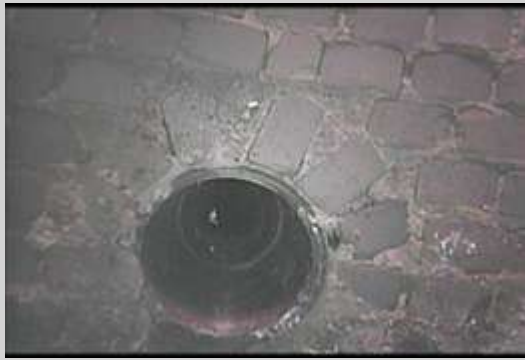
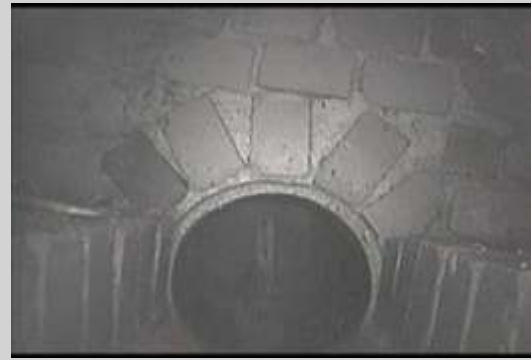
6 O'Clock Inflow

Pipe In @ 6 O'Clock

Drop In @ 6 O'Clock

Invert Depth: **7.22** (ft.) Flow Characteristics: **Fast**

Drop: **Outside** Rod and Bar

Angled: **Yes** Reading: **10.62** (ft.)

Drop Condition: **Open**

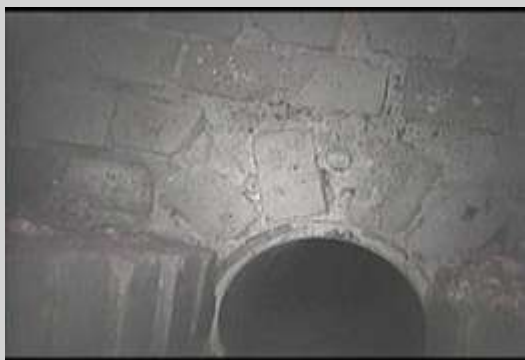
9 O'Clock Inflow

Pipe In @ 9 O'Clock

Pipe Height: **8.4** (in.) Rod and Bar (Angled)

Pipe Material: **Clay** ☐ Pipe Lined

Infiltration: **None** Pipe Seal Cond: **Sound**
